**RE: Wanaque River Remedial Investigation Report – Revised July 2011**  
**DuPont Pompton Lakes Works**  
**Pompton Lakes, New Jersey**  
**PI #007411**

Enclosed for your review is the Wanaque River Remedial Investigation Report (RIR) for the Pompton Lakes Works Site located in Pompton Lakes, New Jersey. One bound copy and three CDs each containing a complete set of figures are included herein.

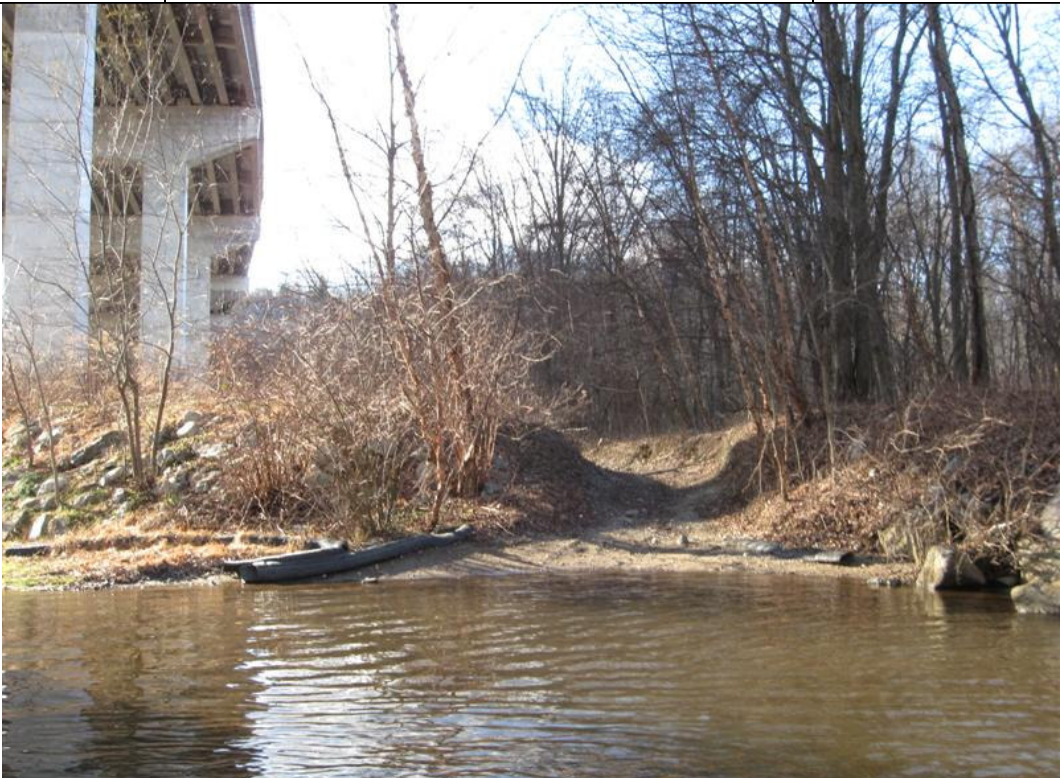
<b>Direction Photo Taken:</b> West			
<b>Description:</b> ATV trail beneath I-287
